A typical childcare building is considered as a case study to explore opportunities to reduce the site energy. Due to the nature of this project, the demanded energy consumption was fully investigated. A dynamic thermal model of the childcare building is simulated with TRNSys software, similar to the characteristics of the real building as much as possible. The COVID-19 pandemic caused fluctuations in the occupancy rates and energy consumption in the studied childcare centre. Hence, Australian and international standards are sourced to have a reliable model.

This report summarises the findings of the performed analysis on the existing conditions and provides recommendations for the improvement of the building conditions and the minimisation of the energy consumption in a childcare centre in the City of

4.1. Case study description

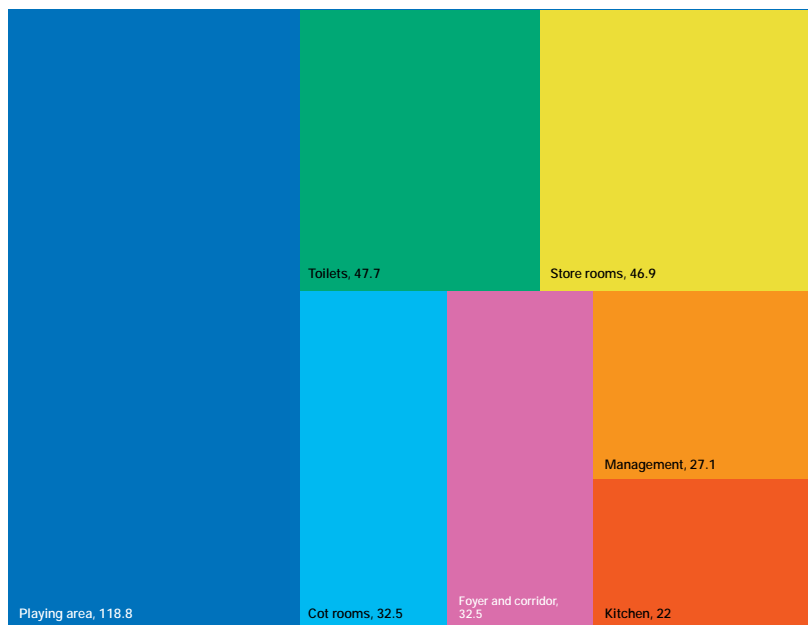
The building was constructed in 1995. The building class, according to the National Construction Code, is '9b: An assembly building including a trade workshop or laboratory in a primary or secondary school' [2]. The building has only one floor with an under-ceiling height of 2.7 m. Figure 2 illustrates the treemap chart of the gross internal area of the case study building. The total gross floor area is 327 m², and the net lettable area is 270 m². →

Figure 2. Gross floor divided area of case study building.

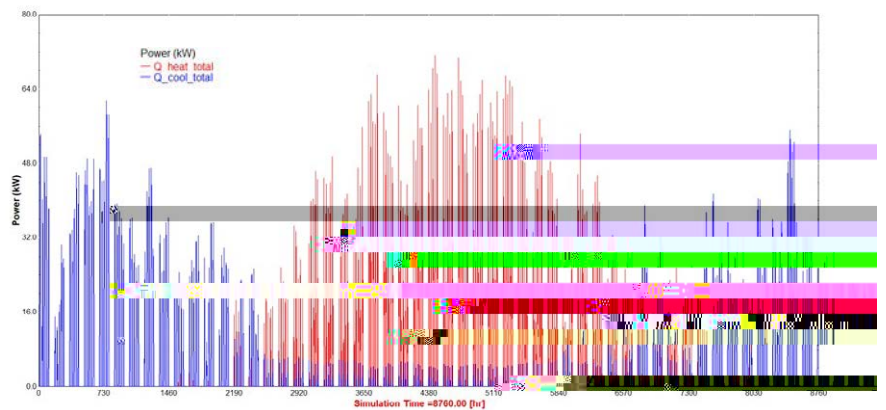
The result of the childcare centre building simulation is presented in this section. Hourly energy demand for heating and cooling (sensible and latent) is illustrated in Figure 5. The monthly energy balance is presented in Figure 6. →

Figure 5. Hourly energy demand for HVAC purposes.

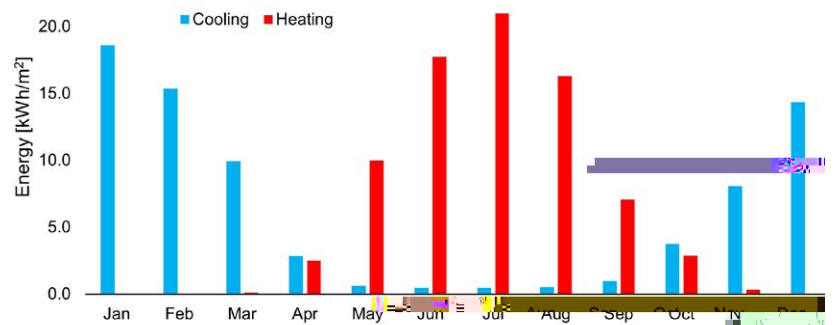
Figure 6. Monthly energy demand for HVAC purposes.

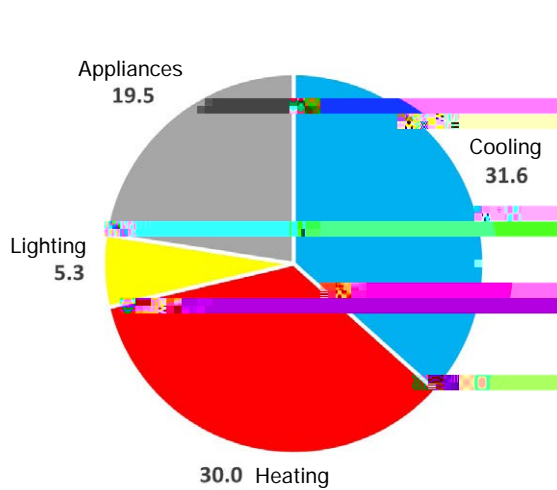
Figure 14. Share of site energy for the baseline – before retrofit.

Between the presented scenarios, Case D has the most retrofitting steps. Also, to evaluate the impact of windows retrofit, Case E is developed and compared with Case D. Table 15 shows the influence of different retrofitting cases on heating and cooling loads. Also, Table 16 demonstrates the impact of different retrofit scenarios on electricity consumption in the case study childcare centre. The result indicates that by improving the building condition, 41.9% of the needed electricity can be reduced. Comparison between Case D and Case E demonstrated that when applying other retrofit choices, changing windows does not have a major impact, considering its high cost. A more detailed illustration of the retrofitting impact is presented in Figures 13-15. →
